## *BIHAR FLOODS*

### *(Kosi Region)*

Flood Inundated areas in part of Bihar state  
Based on the analysis of Radarsat data of 24-August-2008

## IMPORTANT FLOOD INUNDATION MAPS

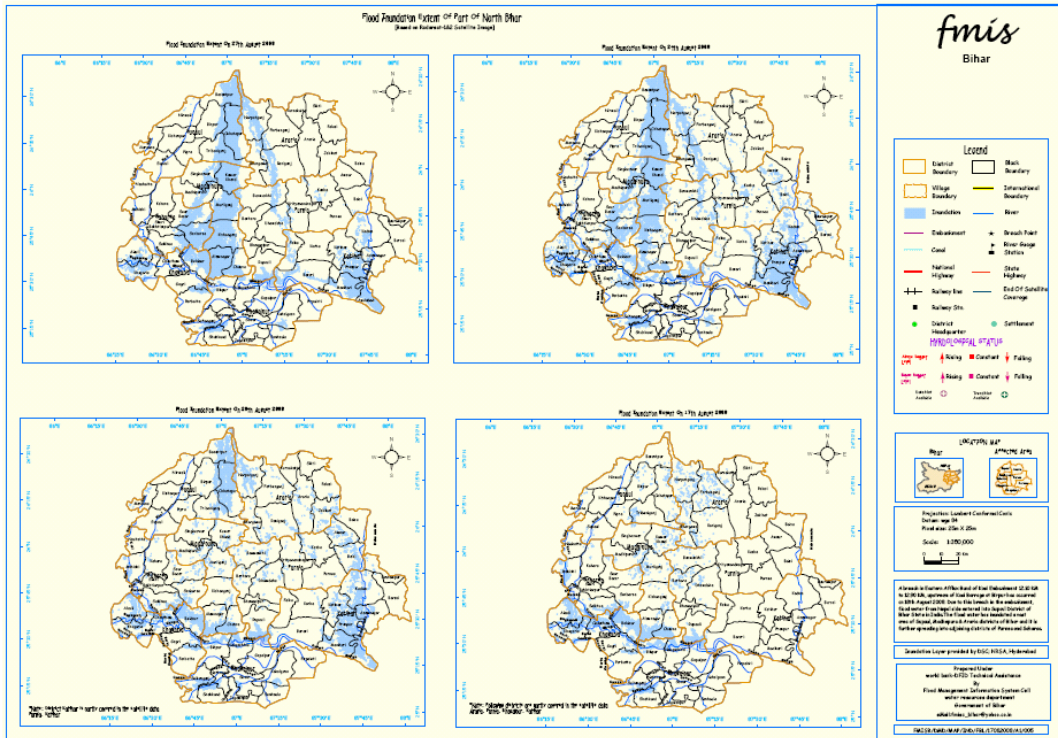
Map of the Madhepura region in Bihar, India, showing the distribution of water bodies and land use. The map includes labels for various locations: Jaynagar, To Laukahu, Supaul, Madhepura, Saran, Munger, and Begusarai. It also shows the Ganges River and the Nalanda District. A legend at the bottom left identifies symbols for water bodies, roads, and land use. A scale bar at the bottom right indicates a distance of 1000 meters. The map is titled 'Map of the Madhepura region in Bihar, India'.

Based on the analysis of Radarsat-2 data of 27-August-2008
